NATIONAL DAM SAFETY PROGRAM. SALISBURY MILLS DAM, INVENTORY NUM--ETC(U)

| REPORT DOCUMENTATION PAGE | | READ INSTRUCTIONS<br>BEFORE COMPLETING FORM |
|--|---|--|
| 4. TITLE (and Subtitle)<br>Phase I Inspection Report<br>Salisbury Mills Dam<br>Moodna Creek Basin, Orange County, New York<br>Inventory No. N.Y. #4 | | 5. TYPE OF REPORT & PERIOD COVERED<br>Phase I Inspection Report<br>National Dam Safety Program |
| 17. DISTRIBUTION STATEMENT<br><br><i>6</i> National Dam Safety Program. Salisbury Mills Dam, Inventory Number 4, <del>XXXX</del> Moodna Creek Basin, Orange County, New York. Phase I Inspection Report | | |

DATE: 19 April 1978

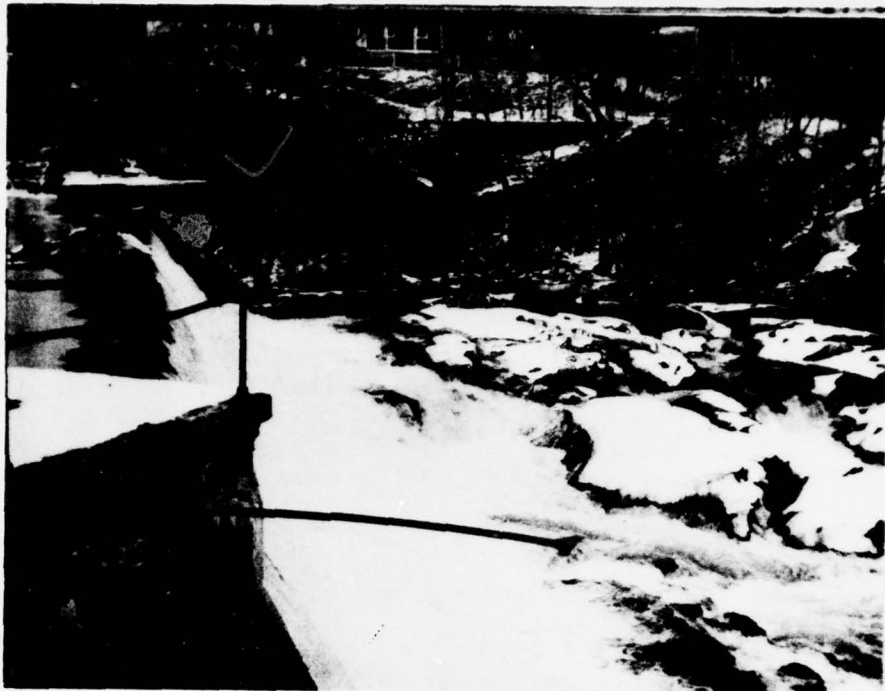
①

DAM (LOOKING N-E)

| VISUAL EXAMINATION OF | OBSERVATIONS | REMARKS OR RECOMMENDATIONS |
|---|--|---|
| SURFACE CRACKS<br>CONCRETE SURFACES | SOME CRACKING AND SPALLING IS<br>VISIBLE ON CONCRETE SURFACES.<br>WATER PLUMBING OVER THE SPILLWAY PREVENTS<br>EXAMINATION OF CONCRETE | SEE PHOTO # 1 |

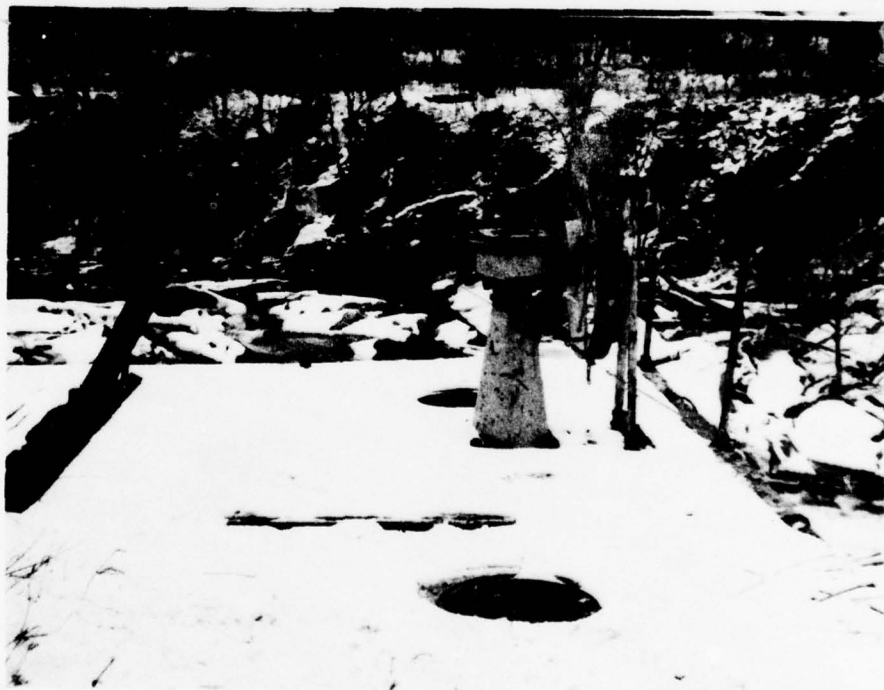
②

GATE HOIST MECHANISM AT INTAKE STRUCTURE  
(RIGHT ABUTMENT)

| VISUAL EXAMINATION OF | OBSERVATIONS | REMARKS OR RECOMMENDATIONS |
|---|--|---|
| WATER PASSAGES | 4' DIA. GATED INTAKE CONDUIT & TRASH RACK AT RIGHT<br>ABUTMENT LEADING TO 6' DIA. PENSTOCK & OUTLET. GATE<br>HOIST MECHANISM DISASSEMBLED CLOSED. CONDITION OF PENSTOCK<br>AND OUTLET IS QUESTIONABLE BECAUSE DEBRIS FROM DEMOLISHED DAM.<br>OWNER STATES THAT GATE IS OPERABLE. INOPERABLE AS IN CONDUIT<br>AT LEFT ABUTMENT. | See Photos 3, 2, 6 |

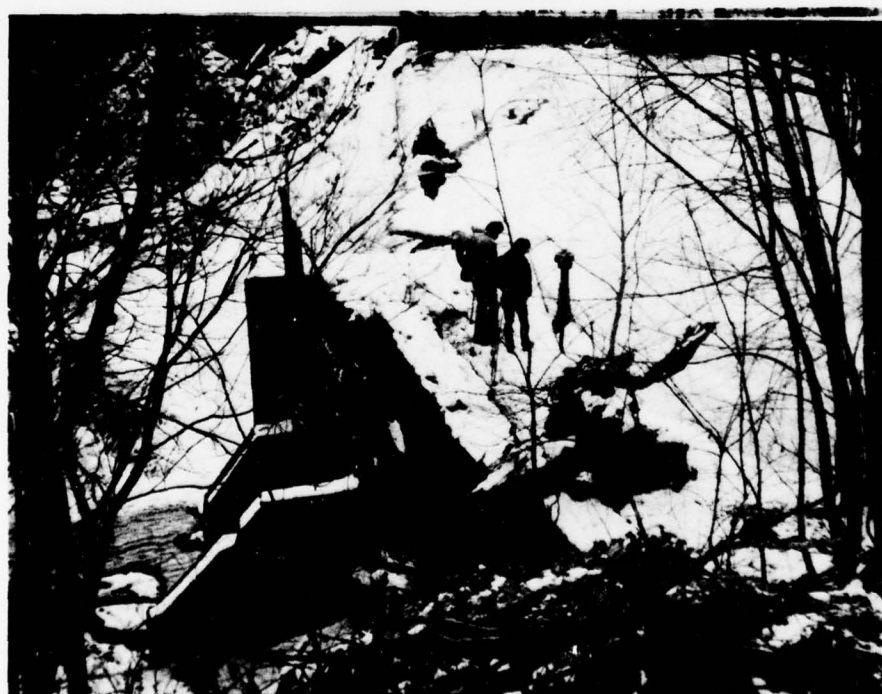
④ LEFT ABUTMENT TIE IN WALL

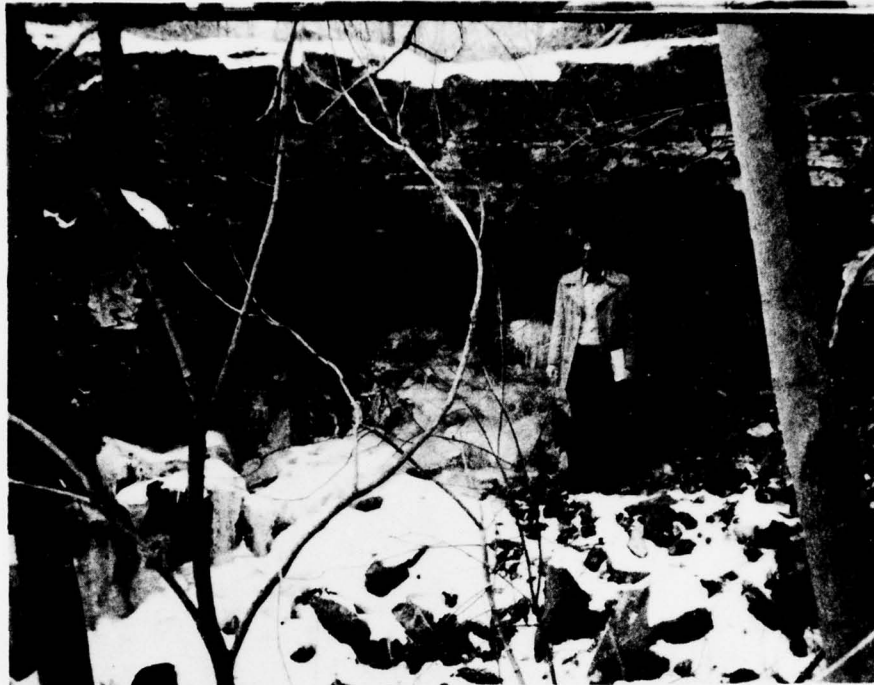
⑤ VOID AND SEEPAGE AT D/S FACE LEFT ABUTMENT  
TIE IN WALL

Visual inspection revealed the left masonry abutment tie-in wall to have significant seepage and extensive loss of stone on the downstream face which could result in imminent failure at the abutment. The dam is evidently founded on ledge rock and failure of the wall would not undermine the spillway section or the road at the left bank. Visual reconnaissance of the immediate downstream area indicates an absence of development in the floodplain which would be affected by a partial failure of the dam. A fire in the mill at the right bank and subsequent demolition has left the dam in an

a. Safety - This dam exhibits serious operational and maintenance deficiencies. The left masonry tie-in abutment wall exhibits extensive loss of stone at the downstream face and significant seepage and is considered to be in imminent danger of failure. The dam is considered to be unsafe in its present condition.

| VISUAL EXAMINATION OF | OBSERVATIONS | REMARKS OR RECOMMENDATIONS |
|---|--|---|
| STRUCTURAL CRACKING | NONE OBSERVED IN CONCRETE.<br>HUGE LOSS OF STONE AT DISJUNCTION OF LEFT<br>MASONRY ABUTMENT | SEE PHOTO # 5 |

- (1) Draining the pool
- (2) Breaching or removing the dam and restoring the creek to the pre-construction conditions.
- (3) Repairing the left abutment tie-in wall.

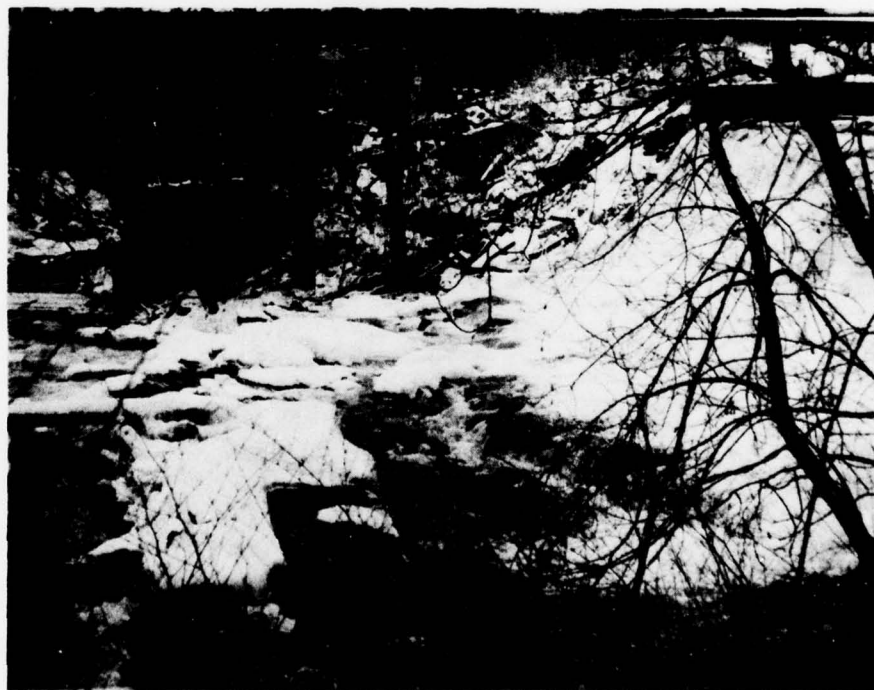
⑥ DEMOLITION OF OLD MILL AT RIGHT BANK  
(LOOKING S-W)

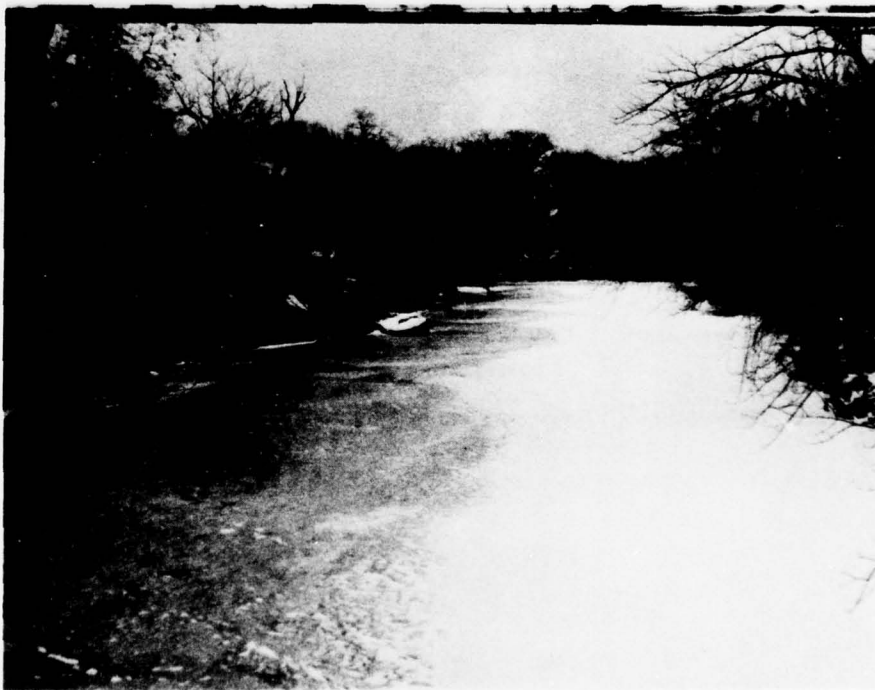
⑧ LOOKING UPSTREAM
